Manhole Inspection Summary

Manhole # S71U__008MH

Insp Date: **12/8/08 2:55 PM**

Location Address: **6713 Holabird Ave.**

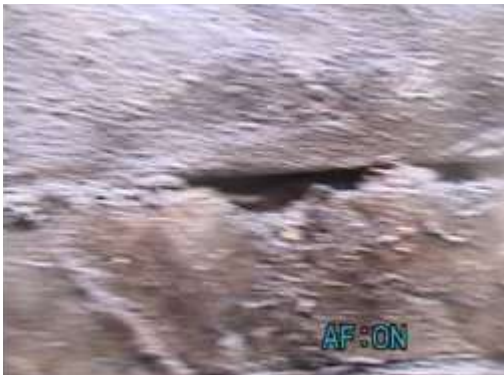
Defect 1

Infiltration: ☐ None ☒ **Joint** ☐ Cracks ☒ **Mortar** ☐ Roots ☒ **Wall**

Mortar and joints deterioration

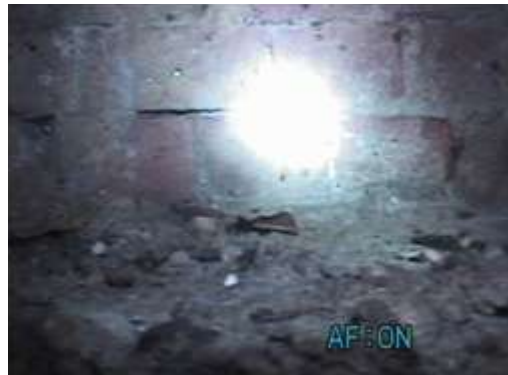
Defect 5

Debris on bench

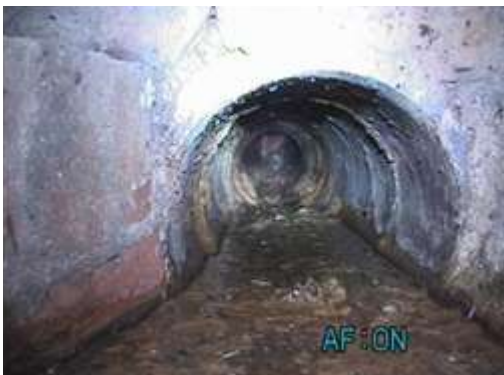
Defect 6

Condition: ☐ Sound ☐ Cracked ☐ Root Intrusion ☐ Deteriorated ☐ Leaks ☒ **Debris**

Debris in channel facing O-12

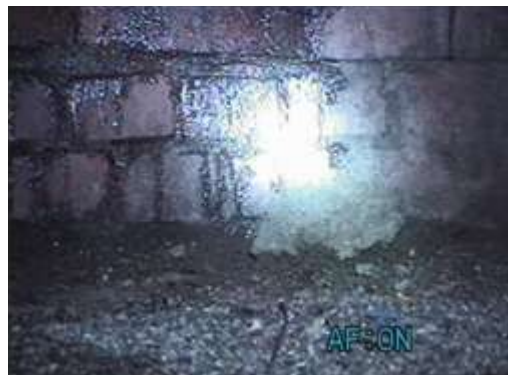
Defect 3

Infiltration from wall

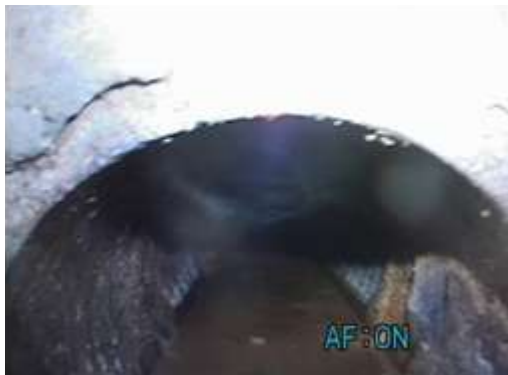
Defect 4

pipe seal crack I5

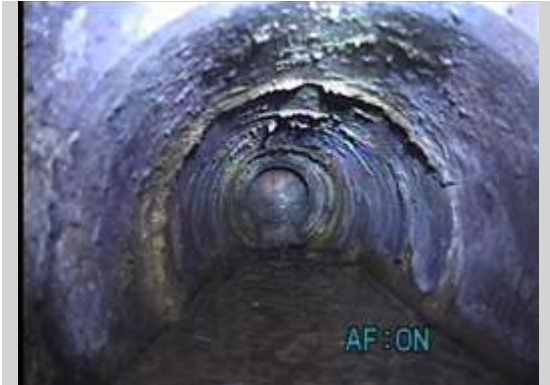
12 O'Clock Outflow

Pipe Height: **8.4** (in.) Rod and Bar (Angled)
Pipe Material: **Clay** ☐ Pipe Lined
Invert Depth: **8.13** (ft.) Flow Characteristics: **Slow**
Deposits: ☐ None ☐ Mud ☒ **Sludge** ☒ **Debris** ☐ Grease
Silt Depth: **0.5** (in.) Deposits Extent: **Light**
Infiltration: **None** Pipe Seal Cond: **Sound**

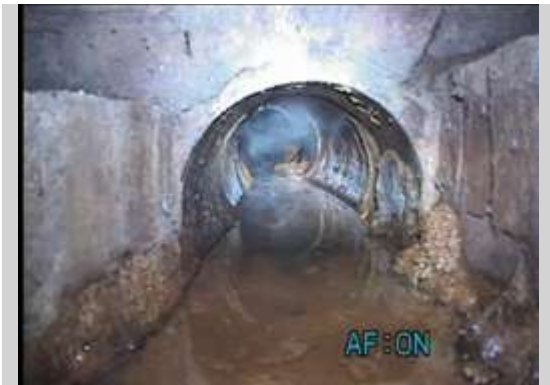
5 O'Clock Inflow

Pipe Height: **8.4** (in.) Rod and Bar (Angled)
Pipe Material: **Clay** ☐ Pipe Lined
Invert Depth: **8.08** (ft.) Flow Characteristics: **Slow**
Deposits: ☐ None ☐ Mud ☒ **Sludge** ☒ **Debris** ☐ Grease
Silt Depth: **0.5** (in.) Deposits Extent: **Light**
Infiltration: **Evidence** Pipe Seal Cond: **Cracked**
